**Flood Control Project Maintenance  
Levee Inspections**

**Fall 2012 Levee Maintenance Deficiency Summary Report**

**Flood Control Project Maintenance  
Levee Inspections  
LMA District Cover Sheet  
Fall 2012 Levee Inspection Results**

**Reclamation District No. 0003 Grand Island**

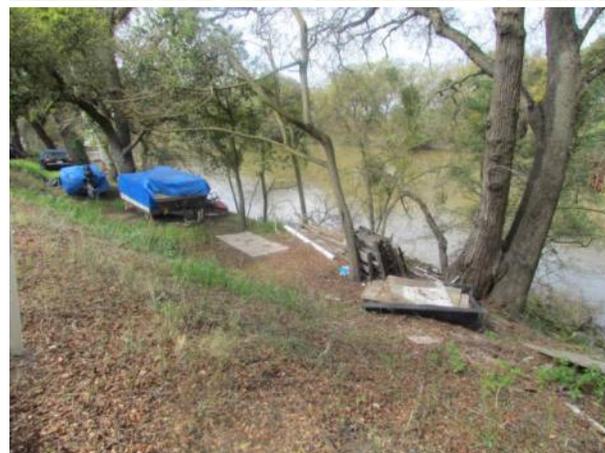
Levee Mile Report Line	6
Start Levee Mile	0.21
End Levee Mile	0.21
Location	Water Side
Category	Earthen Levee
Item	Encroachments
Looking southwest at trash on waterside berm.	
richard_f_20121012_371.jpg

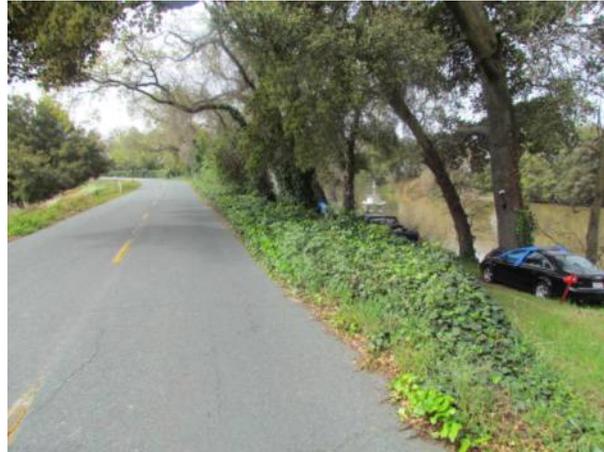
Levee Mile Report Line	7
Start Levee Mile	0.22
End Levee Mile	0.33
Location	Water Side
Category	Earthen Levee
Item	Vegetation
Looking southwest at landscaping on waterside shoulder and slope.	
richard_f_20121012_323.jpg

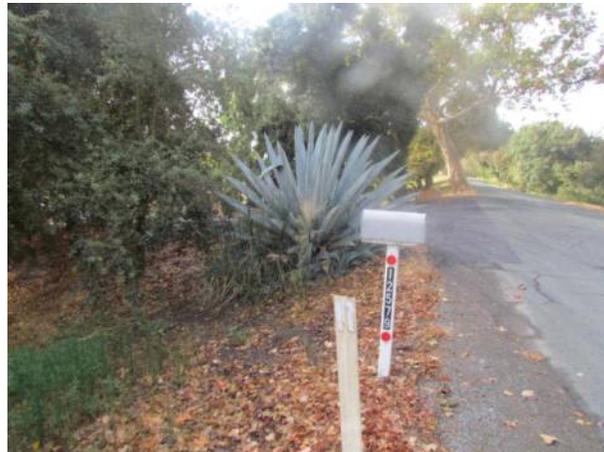
Levee Mile Report Line	9
Start Levee Mile	0.46
End Levee Mile	0.46
Location	Land Side
Category	Earthen Levee
Item	Vegetation
Looking southeast at century plant on landside shoulder.	
richard_f_20121029_897.JPG

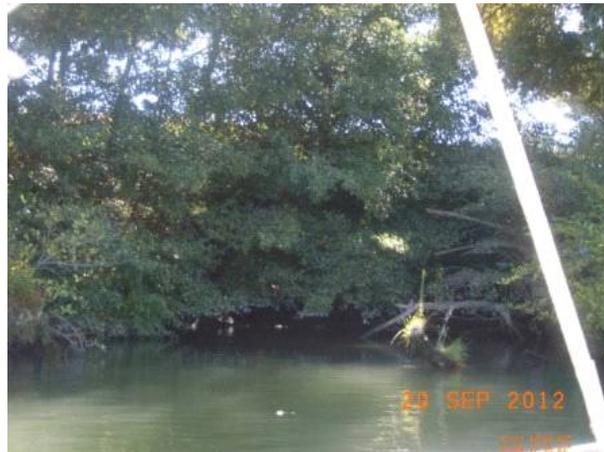
Levee Mile Report Line	11
Start Levee Mile	0.92
End Levee Mile	1.01
Location	Water Side
Category	Supplemental
Item	USACE Erosion Survey
USACE 2012 Photo #1	
USACE2012_STM_25-0_L_1.jpg

LMIR No.	Levee Mile		Category	Item	Location	Rating	Action/Comment	GPS Latitude/Longitude		Issue No. Photo
	Start	End						Start	End	
11	0.92	1.01	Supplemental	USACE Erosion Survey	WS	M Ma	Inspector Comments: 1997 - Erosion of sandy levee on top left bank. Site is downstream of a rock section. Large riparian trees on the bank. 1999 - Upstream half of the reach repaired with rock, except for a 30 ft reach at the upstream end. 2001 - Rock repair on the upstream and downstream ends; no revetment at the trees. 2002 - Rock repair is starting to slide off the geotextile at the upstream end. 2005 - One new small tree has fallen. 2006 - 50 ft pocket at the downstream end and at the upstream end with new rock in between. 2007 - Upstream end has been repaired. 2010 - Some minor new erosion. 2011 - Minor new erosion. 2012: Minor new erosion at the toe. [2012 Site ID: STM_25-0_L]	38.293386 ° -121.582554 °	38.292675 ° -121.582741 °	10 Y

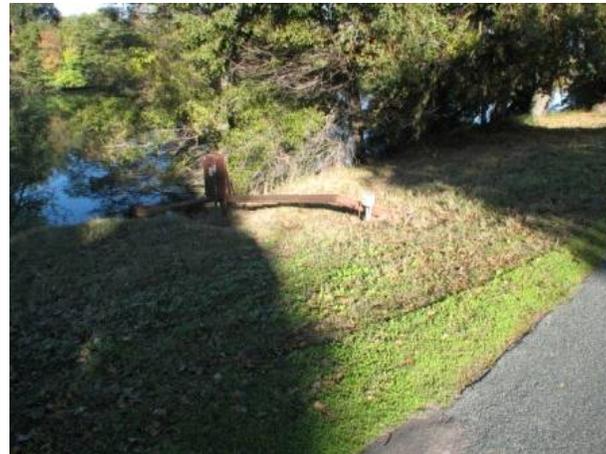
Levee Mile Report Line	12
Start Levee Mile	0.97
End Levee Mile	0.97
Location	Crown
Category	Earthen Levee
Item	Encroachments

Irrigation intake pipe from Steamboat Slough.

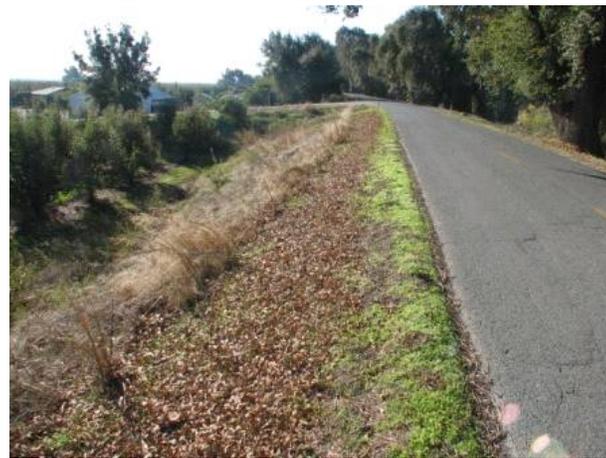
Levee Mile Report Line	13
Start Levee Mile	1.01
End Levee Mile	1.03
Location	Land Side
Category	Earthen Levee
Item	Vegetation

Grass on levee slope and toe exceeds 12" and partially obstructs visibility.

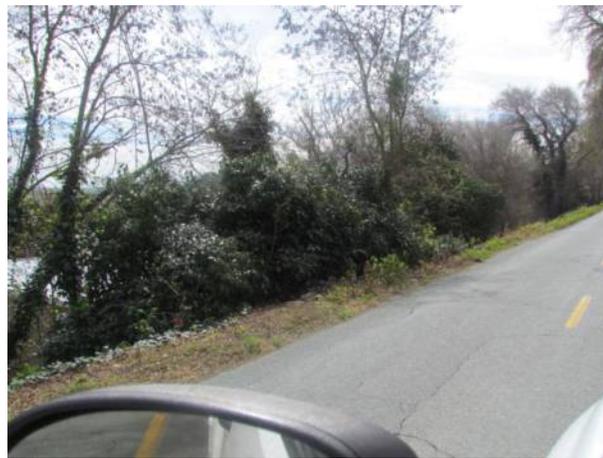
Levee Mile Report Line	15
Start Levee Mile	1.08
End Levee Mile	1.09
Location	Land Side
Category	Earthen Levee
Item	Vegetation

Looking southeast at landscaping on landside slope.

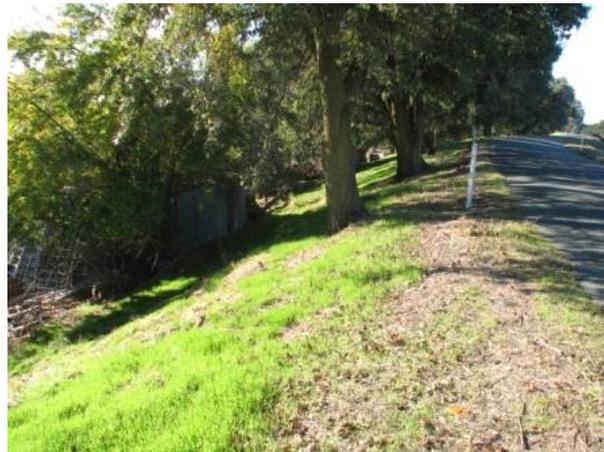
Levee Mile Report Line	18
Start Levee Mile	1.40
End Levee Mile	1.40
Location	Land Side
Category	Earthen Levee
Item	Encroachments
Equipment within 10' of levee toe obstructs access and visibility.	
richard_f_20121012_349.jpg

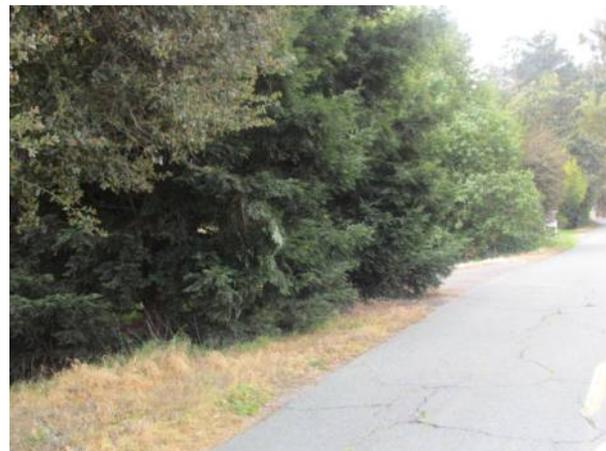
Levee Mile Report Line	19
Start Levee Mile	1.60
End Levee Mile	1.60
Location	Land Side
Category	Earthen Levee
Item	Vegetation
Looking southeast at dense trees on landside shoulder and slope. (updated Spring 2012)	
richard_f_20121012_334.jpg

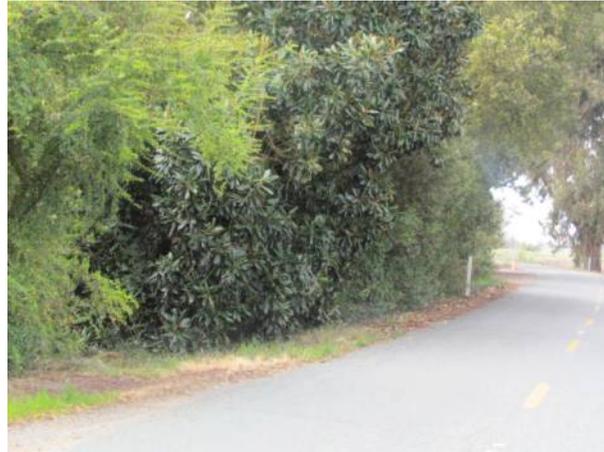
Levee Mile Report Line	20
Start Levee Mile	1.61
End Levee Mile	1.61
Location	Land Side
Category	Earthen Levee
Item	Vegetation
Looking south at dense landscaping on landside shoulder and slope.	
richard_f_20121012_324.jpg

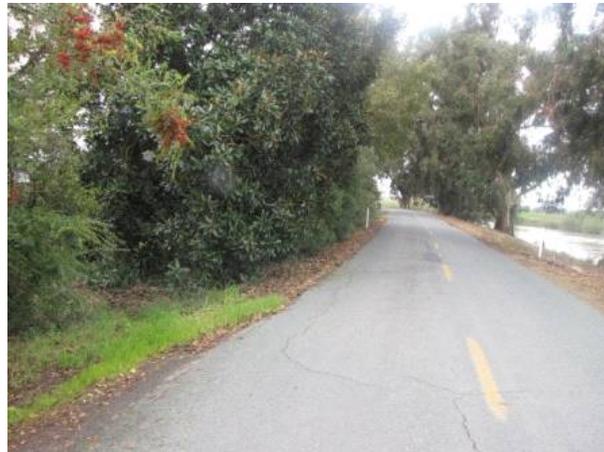
Levee Mile Report Line	22
Start Levee Mile	1.64
End Levee Mile	1.66
Location	Land Side
Category	Earthen Levee
Item	Vegetation
Looking southwest at dense landscaping on landside shoulder and slope.	
richard_f_20121012_335.jpg

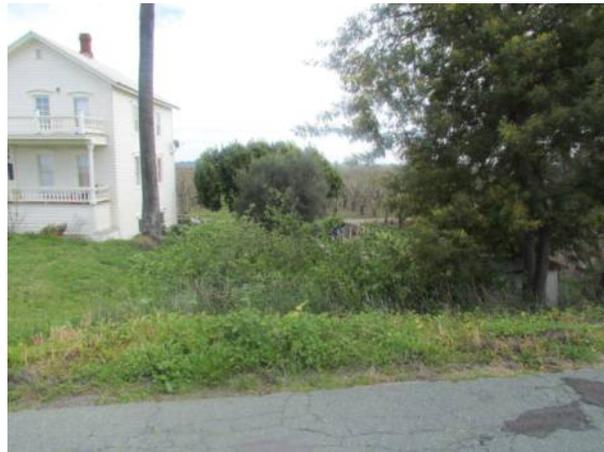
Levee Mile Report Line	24
Start Levee Mile	1.77
End Levee Mile	1.77
Location	Land Side
Category	Earthen Levee
Item	Vegetation
Looking east at vegetation on landside slope.	
richard_f_20121012_325.jpg

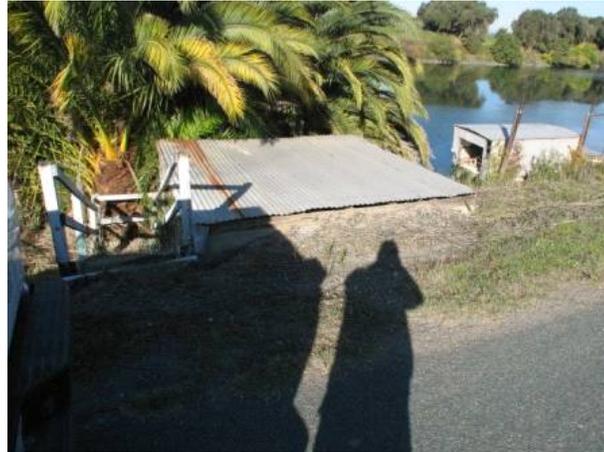
Levee Mile Report Line	26
Start Levee Mile	2.07
End Levee Mile	2.07
Location	Water Side
Category	Earthen Levee
Item	Encroachments
Pipe penetration and pump shed on waterside slope.	
richard_f_20121012_351.jpg

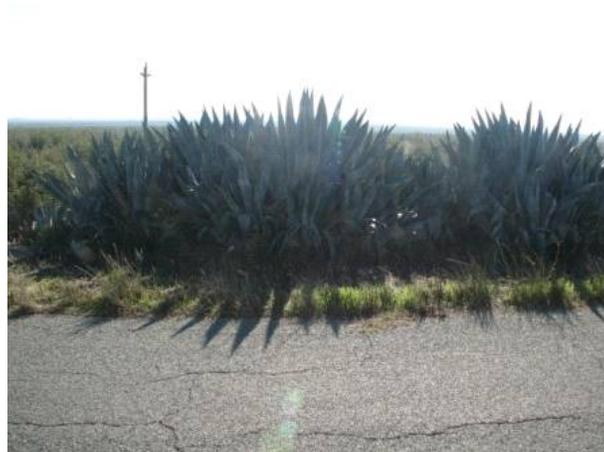
Levee Mile Report Line	37
Start Levee Mile	3.33
End Levee Mile	3.33
Location	Land Side
Category	Earthen Levee
Item	Vegetation
Large cactus on upper levee slope obstructs access and visibility.	
richard_f_20121012_354.jpg

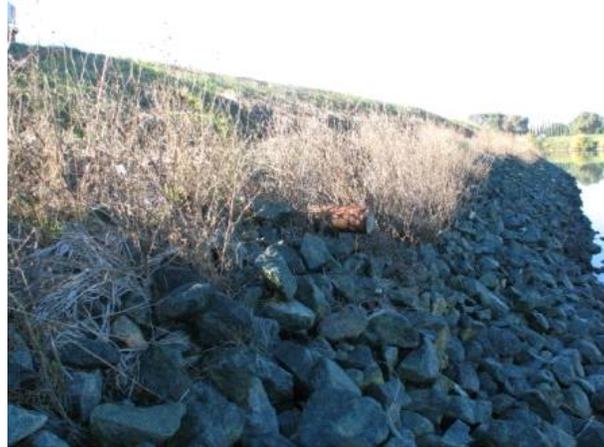
Levee Mile Report Line	38
Start Levee Mile	3.52
End Levee Mile	3.52
Location	Crown
Category	Earthen Levee
Item	Encroachments
Abandoned pipe penetration. Pipe has been grouted.	
richard_f_20121012_355.jpg

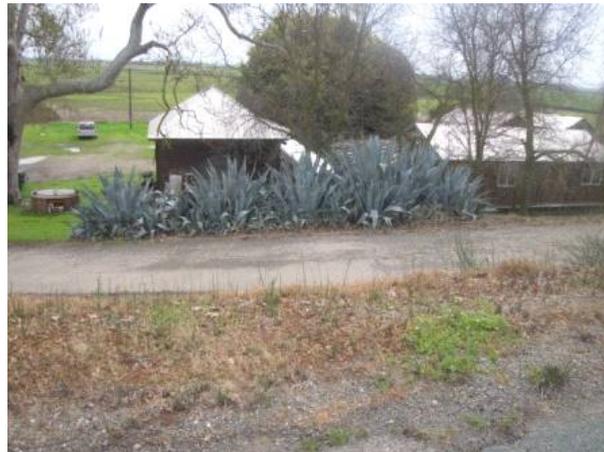
Levee Mile Report Line	48
Start Levee Mile	5.33
End Levee Mile	5.33
Location	Land Side
Category	Earthen Levee
Item	Vegetation
Looking west a century plants on landside slope next to a ramp.	
richard_f_20121012_357.jpg

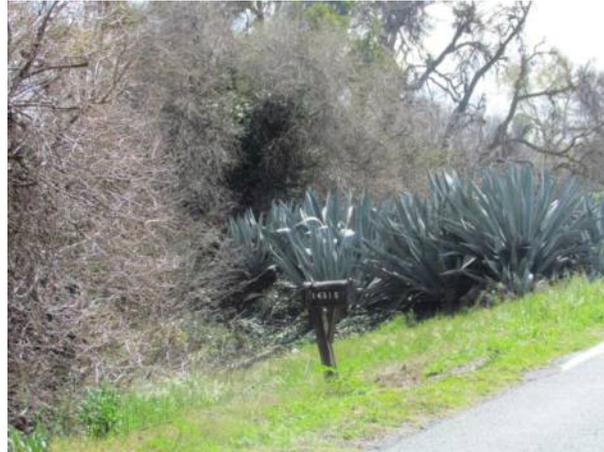
Levee Mile Report Line	50
Start Levee Mile	5.48
End Levee Mile	5.50
Location	Land Side
Category	Earthen Levee
Item	Vegetation
Looking southeast at century plants on landside shoulder and slope.	
richard_f_20121012_352.jpg

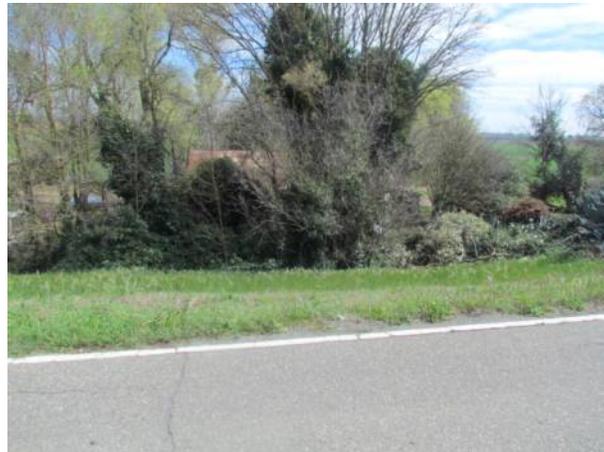
Levee Mile Report Line	51
Start Levee Mile	5.53
End Levee Mile	5.53
Location	Land Side
Category	Earthen Levee
Item	Vegetation
Looking east at landscaping on landside toe.	
richard_f_20121012_353.jpg

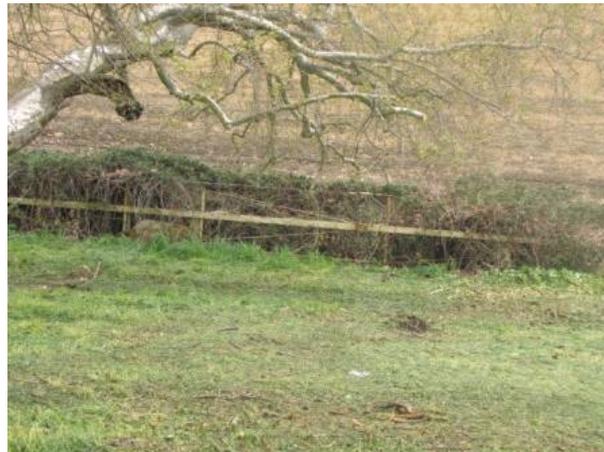
Levee Mile Report Line	53
Start Levee Mile	5.70
End Levee Mile	5.70
Location	Land Side
Category	Earthen Levee
Item	Encroachments
Looking east at dense vegetation covering farm equipment on landside toe.	
richard_f_20121012_358.jpg

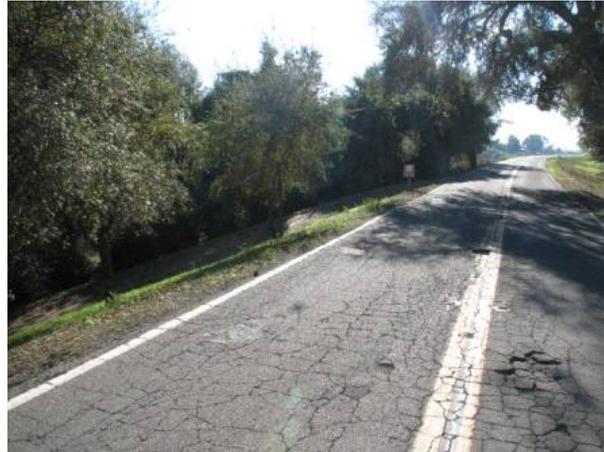
Levee Mile Report Line	54
Start Levee Mile	5.76
End Levee Mile	5.76
Location	Land Side
Category	Earthen Levee
Item	Vegetation
Landscaping on levee slope and within 10' of levee toe obstruct visibility and access.	
richard_f_20121012_359.jpg

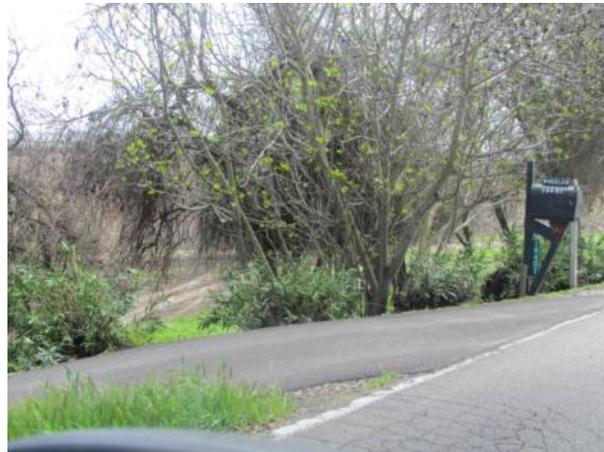
Levee Mile Report Line	54
Start Levee Mile	5.76
End Levee Mile	5.76
Location	Land Side
Category	Earthen Levee
Item	Vegetation
Looking southeast at trimmed landscaping on landside shoulder and slope. (Updated Spring 2012)	
richard_f_20121012_360.jpg

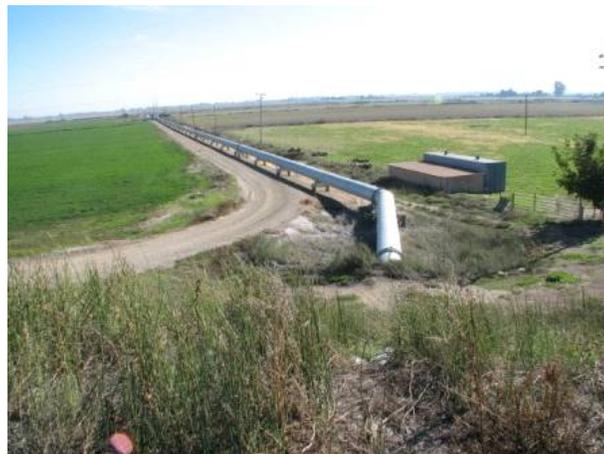
Levee Mile Report Line	58
Start Levee Mile	6.76
End Levee Mile	6.76
Location	Land Side
Category	Earthen Levee
Item	Encroachments
Interior drainage discharge pipe penetrates levee.	
richard_f_20121012_361.jpg

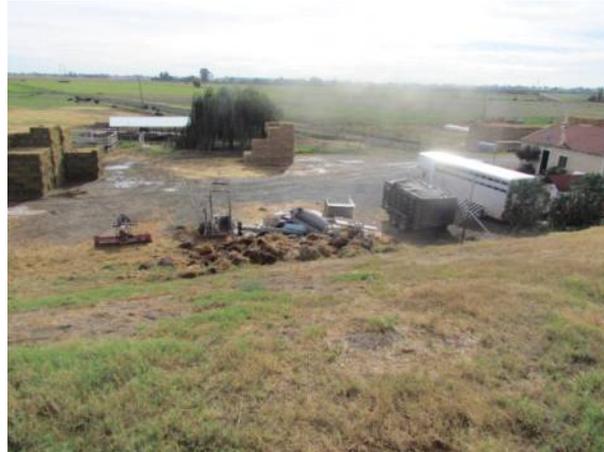
Looking east at garbage at landside toe.

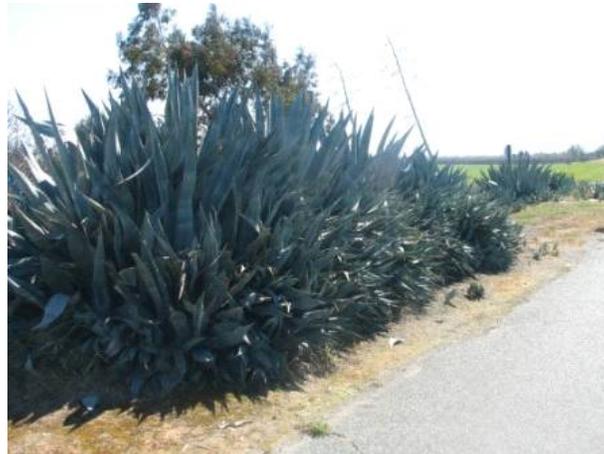
Levee Mile Report Line	62
Start Levee Mile	7.08
End Levee Mile	7.10
Location	Land Side
Category	Earthen Levee
Item	Vegetation

Large Cactus plant on landside shoulder block view of levee slope from LM 7.08 to 7.10

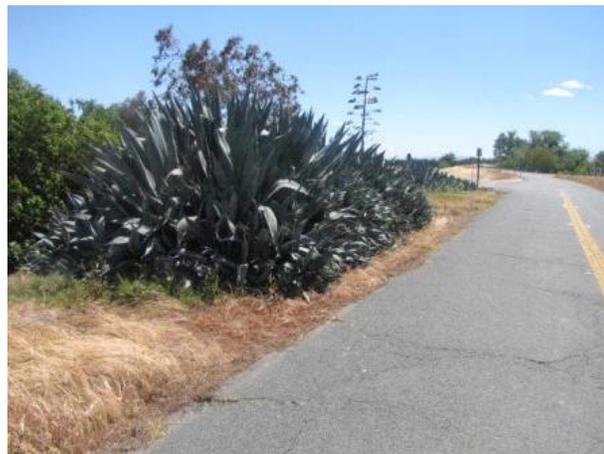
Levee Mile Report Line	62
Start Levee Mile	7.08
End Levee Mile	7.10
Location	Land Side
Category	Earthen Levee
Item	Vegetation

Looking northeast at updated picture (5/2010) century plant on landside shoulder and slope.

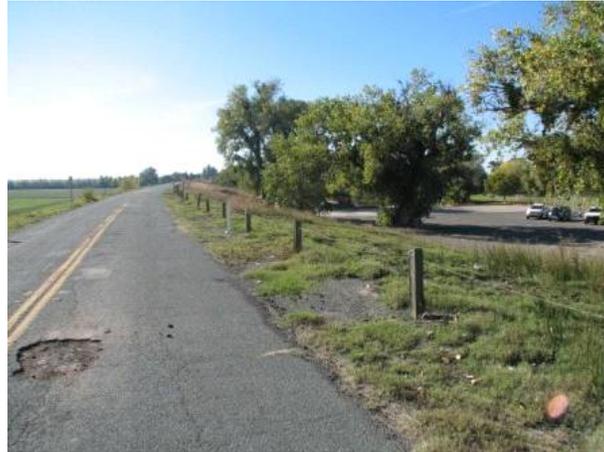
Levee Mile Report Line	63
Start Levee Mile	7.22
End Levee Mile	7.49
Location	Water Side
Category	Earthen Levee
Item	Vegetation
Vegetation on levee slope near boat launch is partially obstructive.	
richard_f_20121012_362.jpg

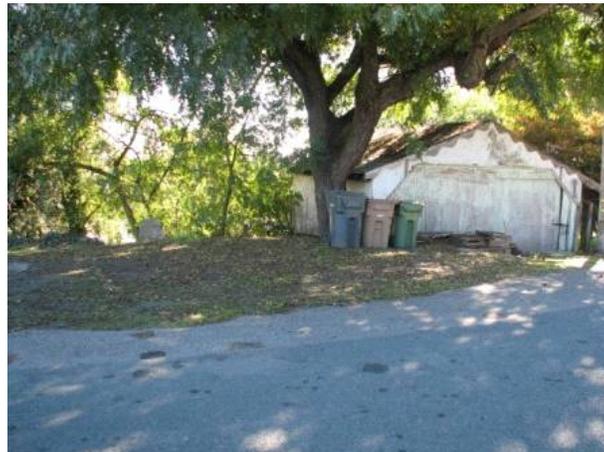
Levee Mile Report Line	66
Start Levee Mile	7.69
End Levee Mile	7.69
Location	Land Side
Category	Earthen Levee
Item	Encroachments
Buildings obstruct access and visibility of levee slope and toe.	
richard_f_20121012_363.jpg

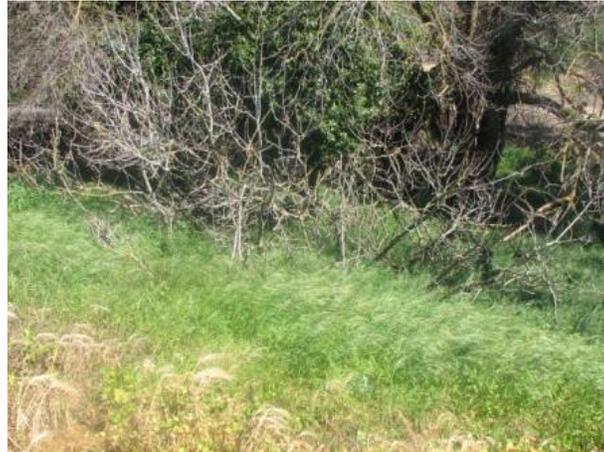
richard\_f\_20121012\_372.jpg

Front view of dense trees at landside toe.

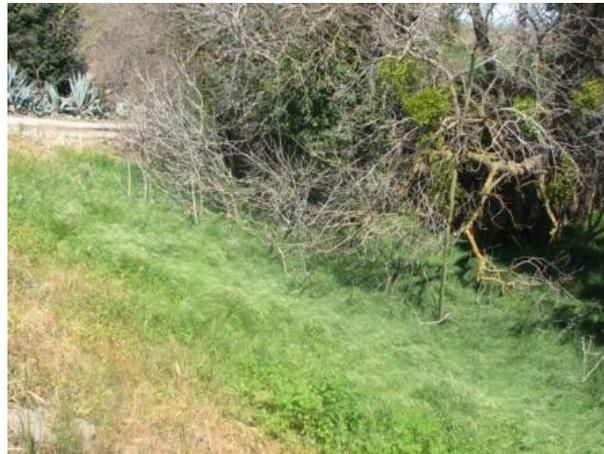
richard\_f\_20121012\_373.jpg

Levee Mile Report Line	68
Start Levee Mile	7.81
End Levee Mile	7.83
Location	Water Side
Category	Earthen Levee
Item	Vegetation

Side view of dense trees at landside toe.

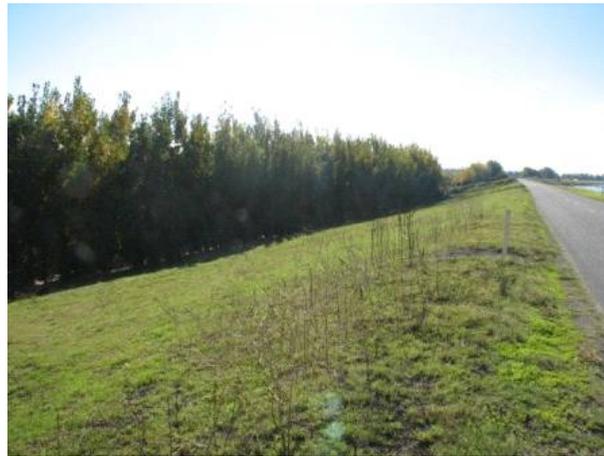
richard\_f\_20121012\_365.jpg

Levee Mile Report Line	69
Start Levee Mile	7.84
End Levee Mile	8.31
Location	Land Side
Category	Earthen Levee
Item	Vegetation

Trees within 10' of levee toe obstruct access and visibility of levee toe.

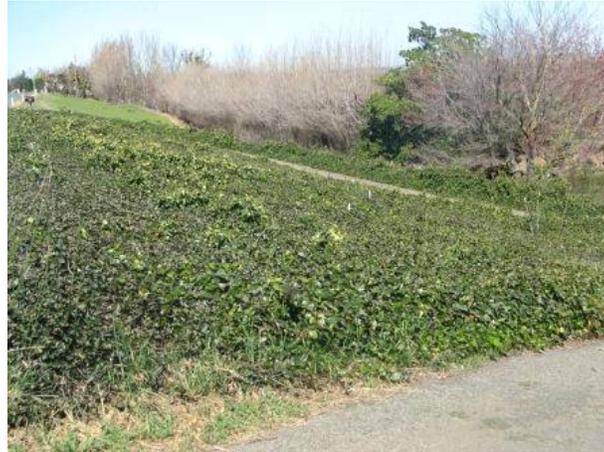
Levee Mile Report Line	71
Start Levee Mile	7.95
End Levee Mile	8.00
Location	Land Side
Category	Earthen Levee
Item	Vegetation
Landscaping (Ivy) on landside slope blocking view of levee from LM 7.95 to 8.00	
richard_f_20121012_342.jpg

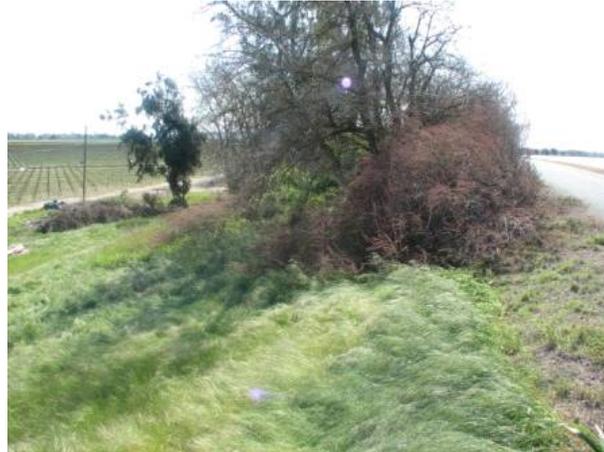
richard\_f\_20121012\_344.jpg

Side view of trees on landside shoulder.

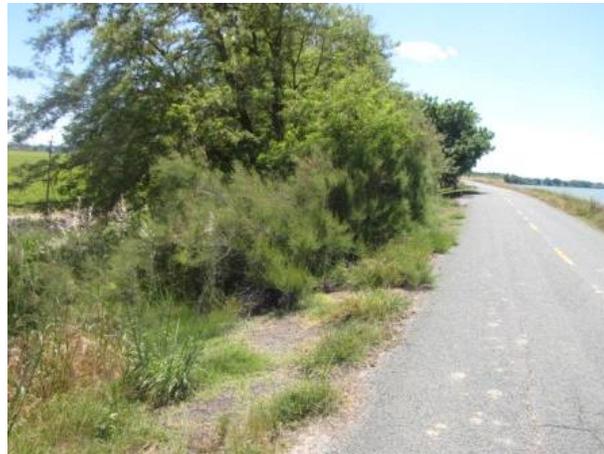
richard\_f\_20121012\_345.jpg

Levee Mile Report Line	86
Start Levee Mile	10.20
End Levee Mile	10.22
Location	Land Side
Category	Earthen Levee
Item	Trim / Thin Trees

Looking north at updated picture (5/10) of dense trees on landside slope.

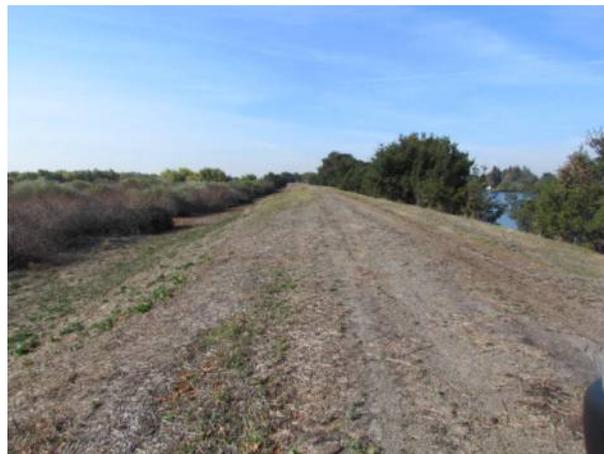
richard\_f\_20121012\_370.jpg

Levee Mile Report Line	88
Start Levee Mile	10.87
End Levee Mile	11.01
Location	Land Side
Category	Earthen Levee
Item	Vegetation

Looking south at typical view of levee between levee mile 10.87 to 11.01

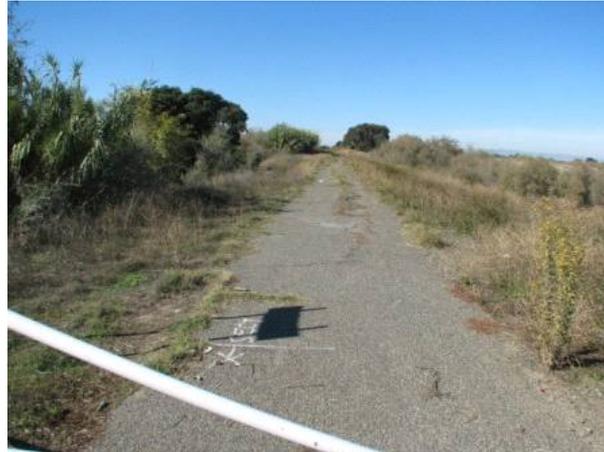
richard\_f\_20121012\_411.jpg

Photo of obstructive vegetation on levee slopes.

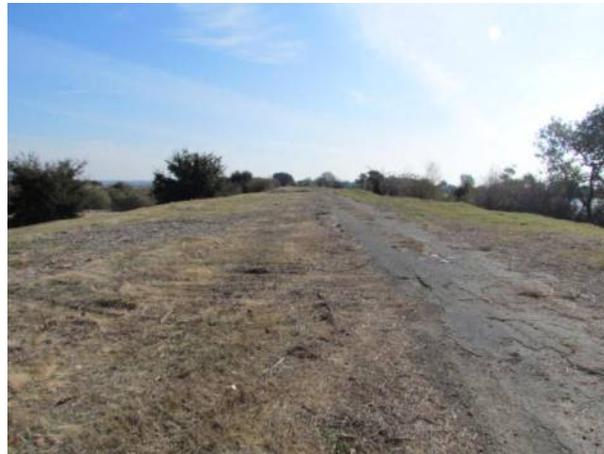
richard\_f\_20121012\_412.jpg

Levee Mile Report Line	1
Start Levee Mile	0.00
End Levee Mile	0.40
Location	Land Side
Category	Earthen Levee
Item	Vegetation

Looking northeast a typical view of levee between levee mile 0.00 to 0.44

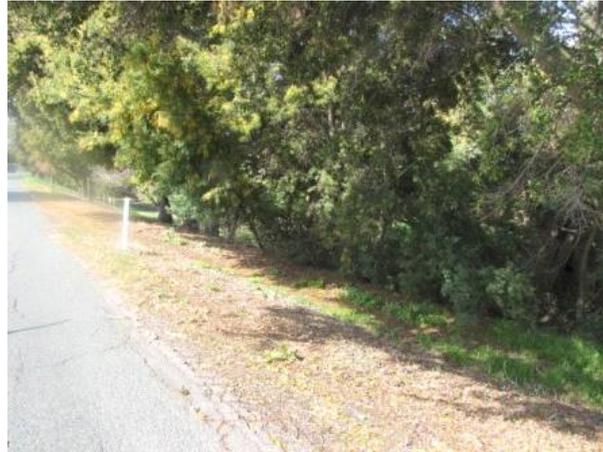
Levee Mile Report Line	13
Start Levee Mile	3.29
End Levee Mile	3.29
Location	Land Side
Category	Earthen Levee
Item	Trim / Thin Trees
Looking west at dense vegetation on landside slope and toe.	
richard_f_20121012_379.jpg

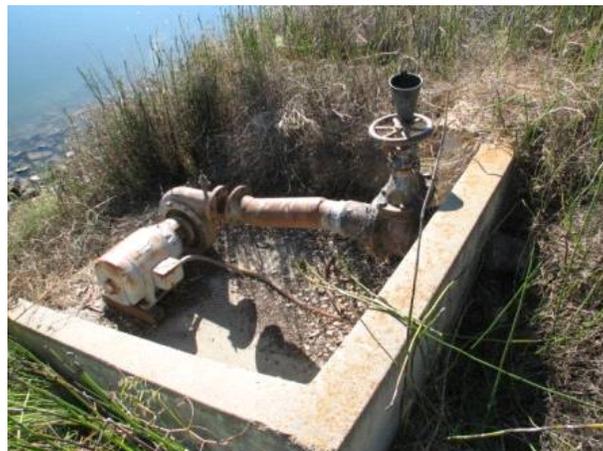
Levee Mile Report Line	15
Start Levee Mile	3.39
End Levee Mile	3.39
Location	Water Side
Category	Earthen Levee
Item	Encroachments
Pipe penetration closure valve in open position.	
richard_f_20121012_400.jpg

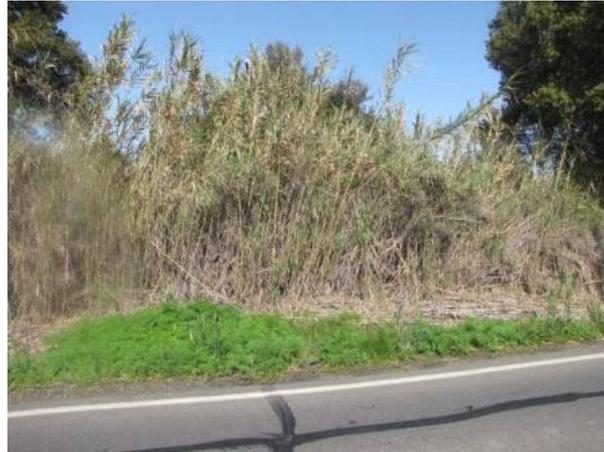
richard\_f\_20121012\_423.jpg

Looking west at dense bamboo on landside slope.

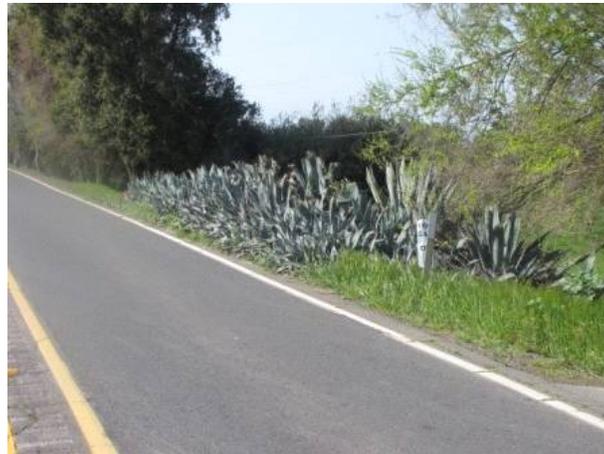
richard\_f\_20121012\_387.jpg

Levee Mile Report Line	21
Start Levee Mile	4.22
End Levee Mile	4.22
Location	Land Side
Category	Earthen Levee
Item	Vegetation

Looking west at cactus on landside slope.

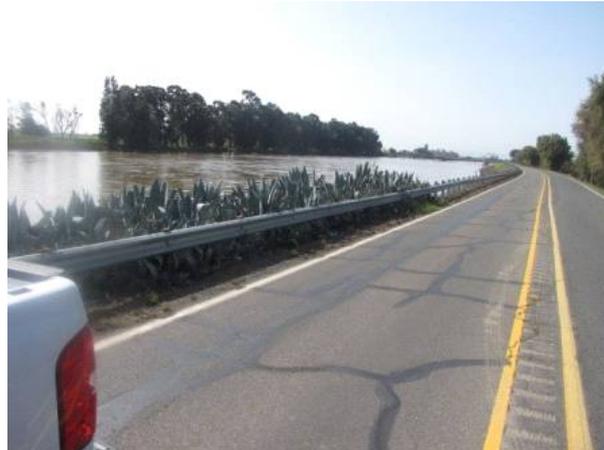
richard\_f\_20121012\_388.jpg

Levee Mile Report Line	21
Start Levee Mile	4.22
End Levee Mile	4.22
Location	Land Side
Category	Earthen Levee
Item	Vegetation

Looking southeast a cactus on waterside shoulder and slope.

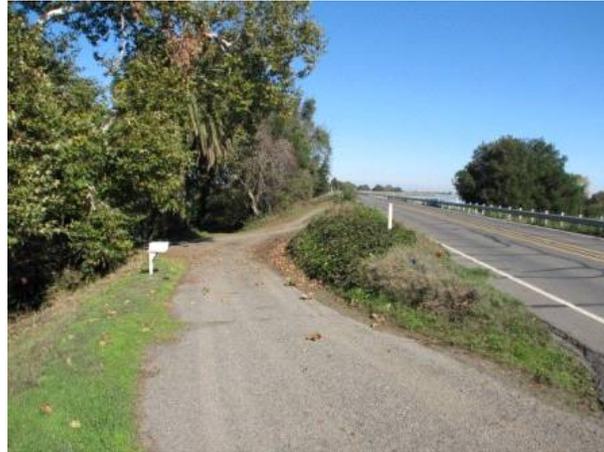
Levee Mile Report Line	24
Start Levee Mile	4.36
End Levee Mile	4.42
Location	Land Side
Category	Earthen Levee
Item	Vegetation
Landscaping on levee slope and toe obstructs access and visibility.	
richard_f_20121012_419.jpg

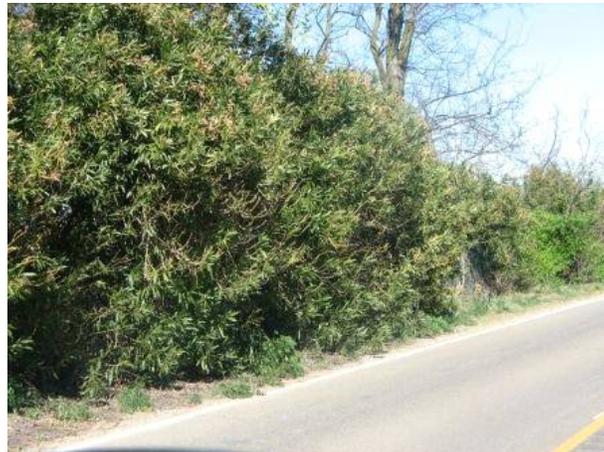
Levee Mile Report Line	31
Start Levee Mile	5.94
End Levee Mile	6.00
Location	Land Side
Category	Earthen Levee
Item	Vegetation
Oleander on landside shoulder blocking view of levee slope from LM 5.94 to 6.00	
richard_f_20121012_382.jpg

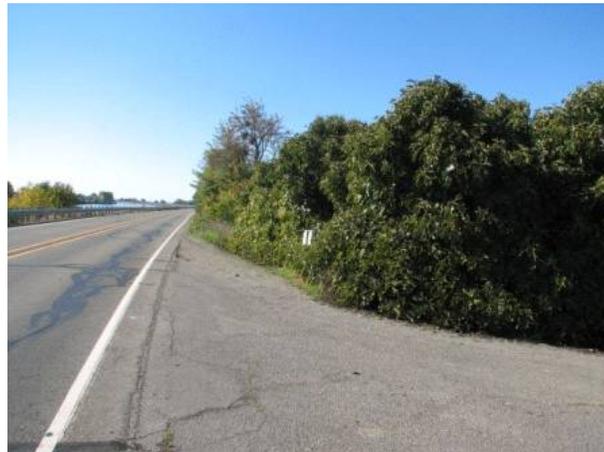
Levee Mile Report Line	31
Start Levee Mile	5.94
End Levee Mile	6.00
Location	Land Side
Category	Earthen Levee
Item	Vegetation
Landscaping on levee slope and toe obstructs access and visibility.	
richard_f_20121012_383.jpg

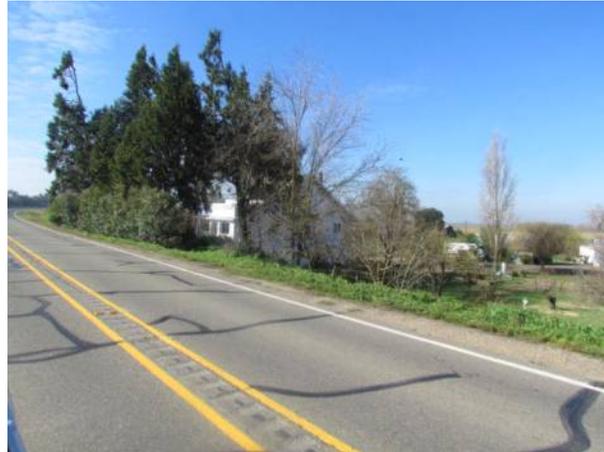
Levee Mile Report Line	33
Start Levee Mile	6.66
End Levee Mile	6.69
Location	Land Side
Category	Earthen Levee
Item	Vegetation
Looking south at landscaping on landside shoulder.	
richard_f_20121012_418.jpg

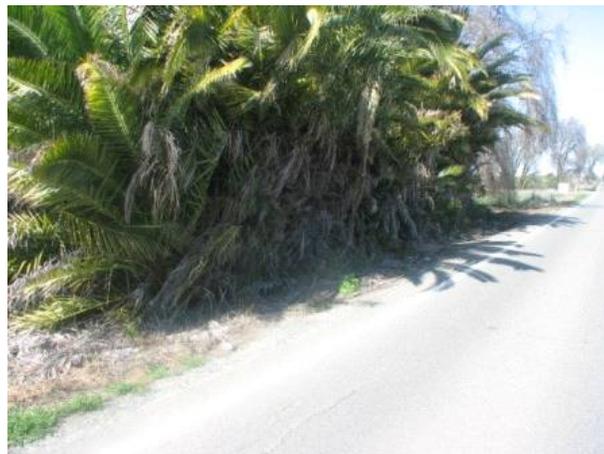
Levee Mile Report Line	34
Start Levee Mile	7.02
End Levee Mile	7.04
Location	Land Side
Category	Earthen Levee
Item	Vegetation
Front view of palm trees on landside shoulder	
richard_f_20121012_385.jpg

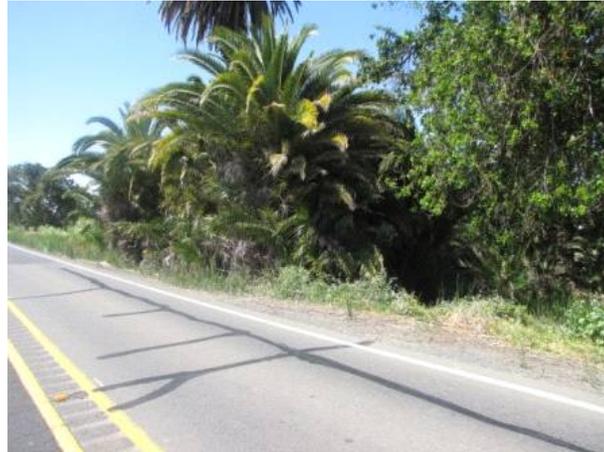
Levee Mile Report Line	34
Start Levee Mile	7.02
End Levee Mile	7.04
Location	Land Side
Category	Earthen Levee
Item	Vegetation
Looking southwest at updated dense veg on landside slope.	
richard_f_20121012_386.jpg

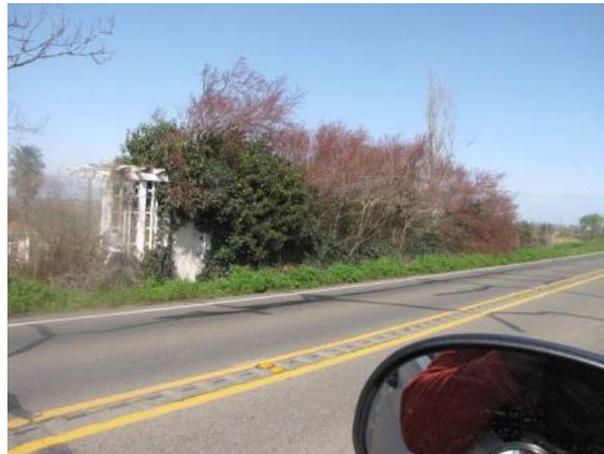
Levee Mile Report Line	36
Start Levee Mile	7.38
End Levee Mile	7.38
Location	Land Side
Category	Earthen Levee
Item	Vegetation
Looking northwest a dense landscaping on landside shoulder and slope.	
richard_f_20121012_402.jpg

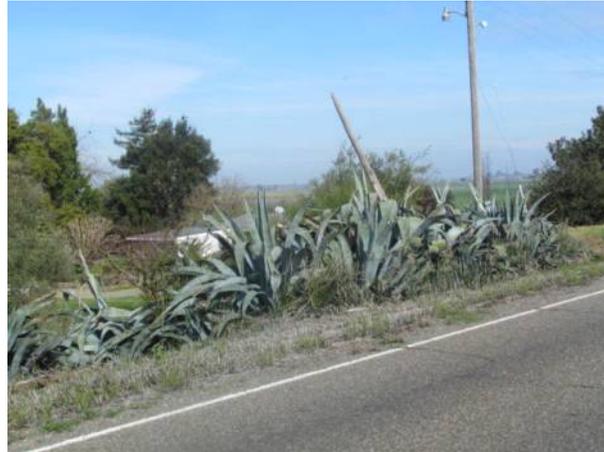
richard\_f\_20121012\_403.jpg

Looking west at cactus on landside shoulder and slope.

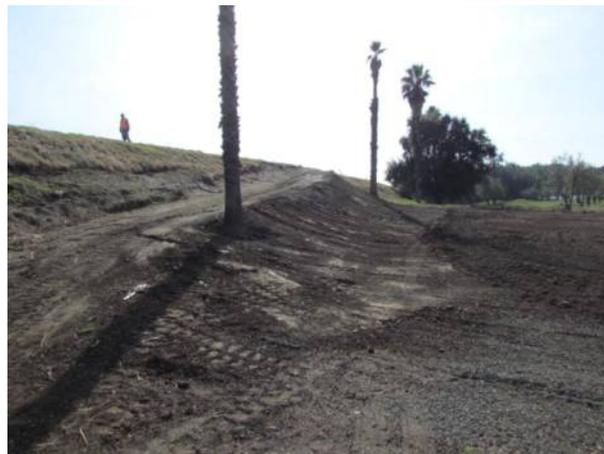
richard\_f\_20121012\_376.jpg

Levee Mile Report Line	43
Start Levee Mile	9.19
End Levee Mile	9.19
Location	Land Side
Category	Earthen Levee
Item	Encroachments

Looking south at unauthorized ramp on landside slope.

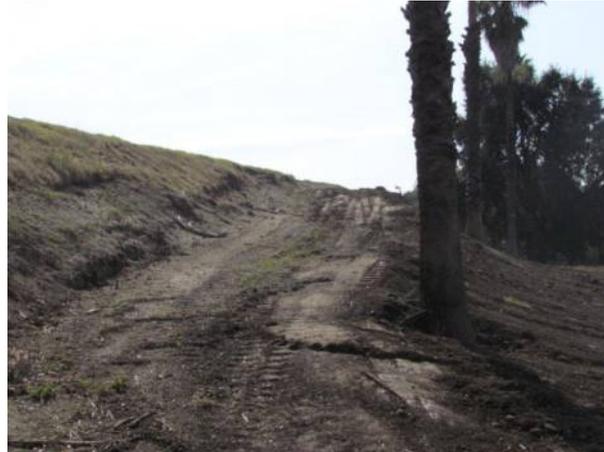
Levee Mile Report Line	43
Start Levee Mile	9.19
End Levee Mile	9.19
Location	Land Side
Category	Earthen Levee
Item	Encroachments
Looking southeast at ramp on landside slope.	
richard_f_20121012_377.jpg

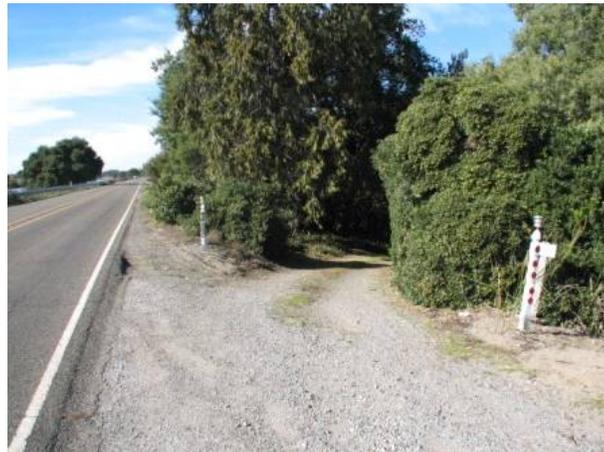
Levee Mile Report Line	53
Start Levee Mile	10.74
End Levee Mile	10.74
Location	Land Side
Category	Earthen Levee
Item	Vegetation
Landscaping on levee slope and toe obstructs access and visibility.	
richard_f_20121012_406.jpg

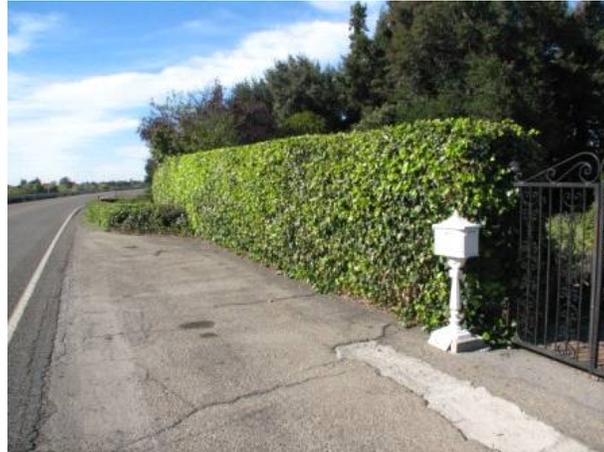
Levee Mile Report Line	54
Start Levee Mile	10.98
End Levee Mile	10.98
Location	Land Side
Category	Earthen Levee
Item	Vegetation
Landscaping on levee slope obstructs access and visibility.	
richard_f_20121012_407.jpg

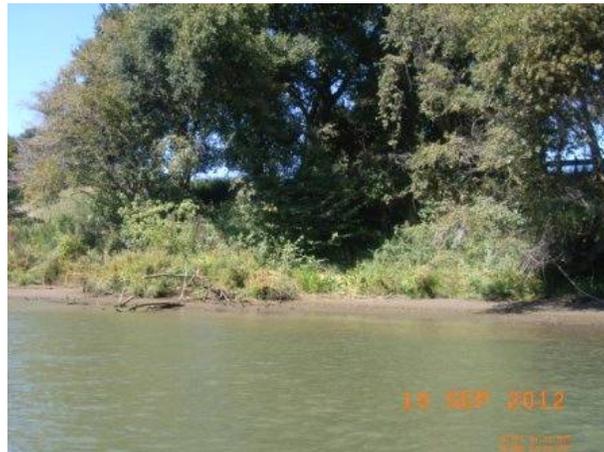
Levee Mile Report Line	57
Start Levee Mile	11.33
End Levee Mile	11.33
Location	Water Side
Category	Supplemental
Item	USACE Erosion Survey
USACE 2012 Photo #1	
USACE2012_SAC_26-3_R_1.jpg

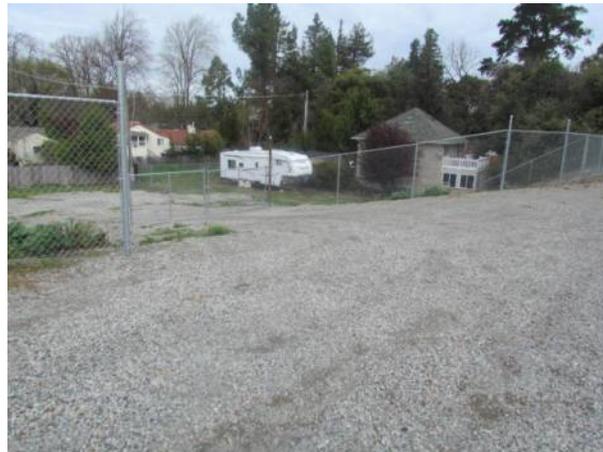
Levee Mile Report Line	63
Start Levee Mile	12.21
End Levee Mile	12.21
Location	Land Side
Category	Earthen Levee
Item	Encroachments
Looking northwest at new fence on landside shoulder and slope.	
richard_f_20121012_420.jpg

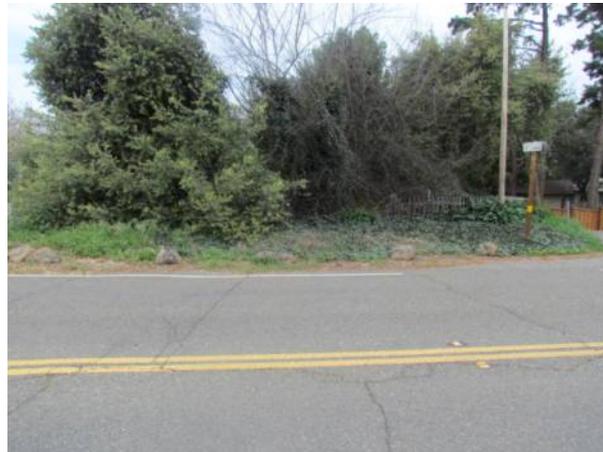
Levee Mile Report Line	65
Start Levee Mile	12.26
End Levee Mile	12.26
Location	Land Side
Category	Earthen Levee
Item	Encroachments
Looking northwest a new wooden fence on landside shoulder.	
richard_f_20121012_422.jpg

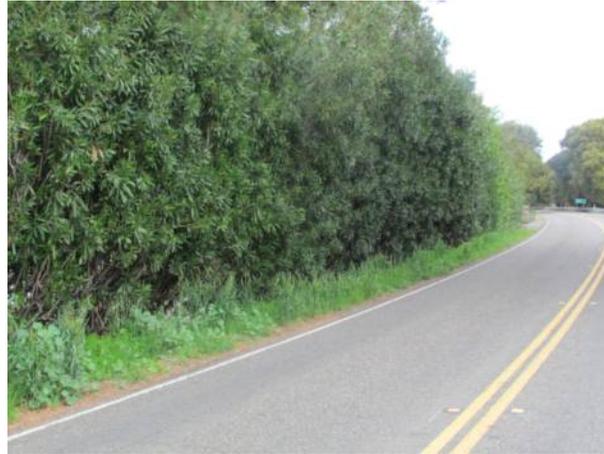
Levee Mile Report Line	66
Start Levee Mile	12.33
End Levee Mile	12.40
Location	Land Side
Category	Earthen Levee
Item	Vegetation
Looking northwest at oleander on landside shoulder.	
richard_f_20121012_395.jpg

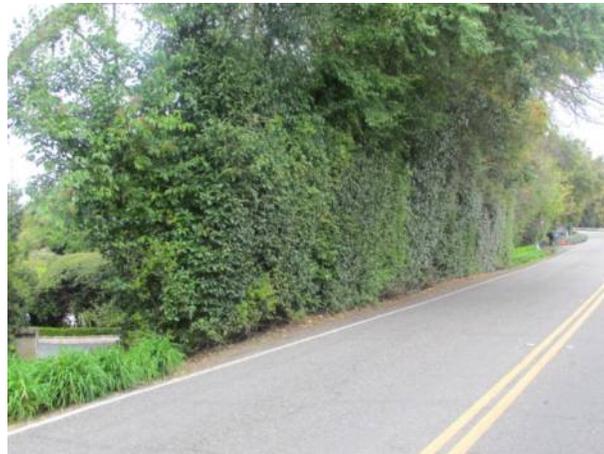
Levee Mile Report Line	67
Start Levee Mile	12.48
End Levee Mile	12.55
Location	Land Side
Category	Earthen Levee
Item	Vegetation
Looking northwest at dense landscaping on landside shoulder.	
richard_f_20121012_396.jpg

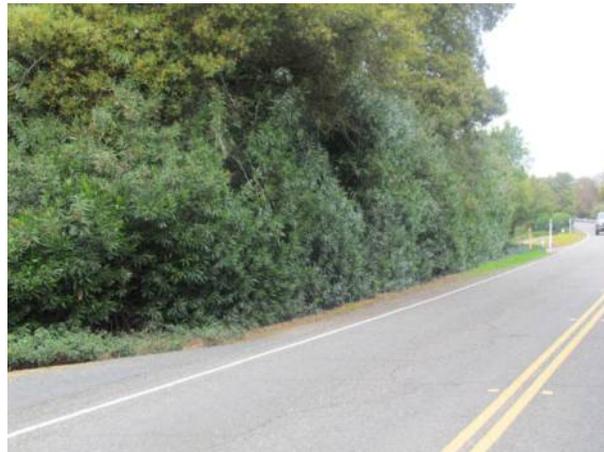
Levee Mile Report Line	69
Start Levee Mile	12.60
End Levee Mile	12.63
Location	Land Side
Category	Earthen Levee
Item	Vegetation
Looking northwest at dense landscaping on landside shoulder and slope.	
richard_f_20121012_397.jpg

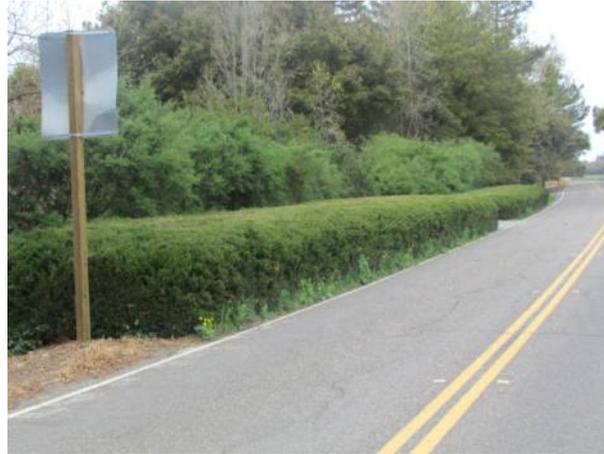
Levee Mile Report Line	70
Start Levee Mile	12.77
End Levee Mile	12.85
Location	Land Side
Category	Earthen Levee
Item	Vegetation
Looking northwest at dense landscaping on landside shoulder and slope.	
richard_f_20121012_398.jpg

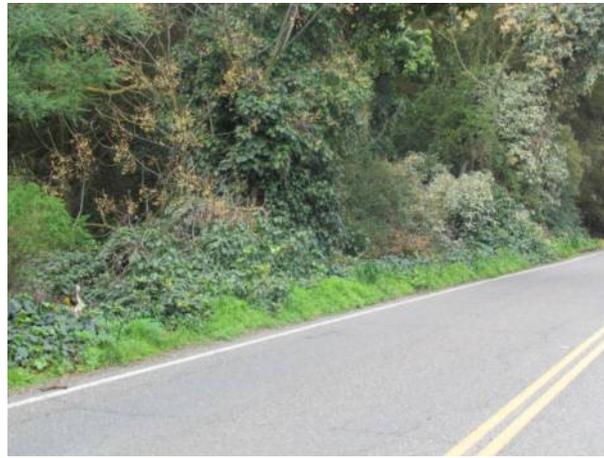
Levee Mile Report Line	71
Start Levee Mile	13.26
End Levee Mile	13.29
Location	Land Side
Category	Earthen Levee
Item	Vegetation
Looking west at dense landscaping on landside shoulder and slope.	
richard_f_20121012_416.jpg

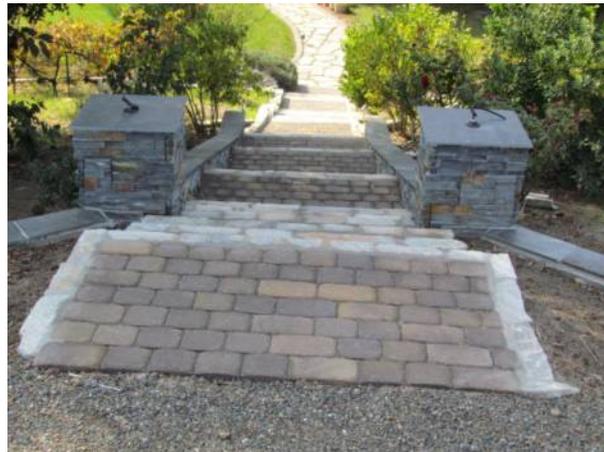
Levee Mile Report Line	72
Start Levee Mile	13.60
End Levee Mile	13.60
Location	Land Side
Category	Earthen Levee
Item	Encroachments
Looking west at stairs on landside slope.	
richard_f_20121012_380.jpg

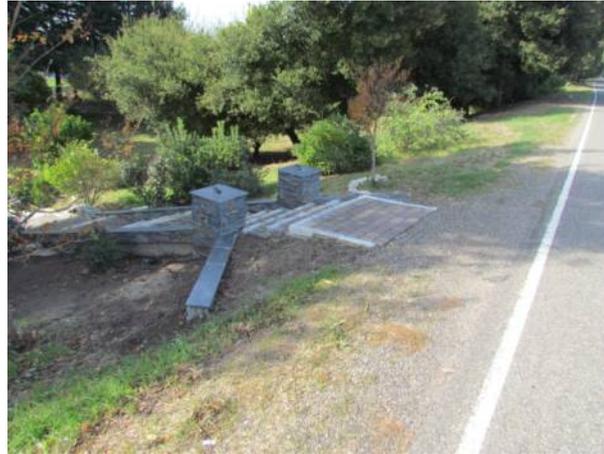
Levee Mile Report Line	72
Start Levee Mile	13.60
End Levee Mile	13.60
Location	Land Side
Category	Earthen Levee
Item	Encroachments
Looking northwest at stairs on landside slope.	
richard_f_20121012_381.jpg

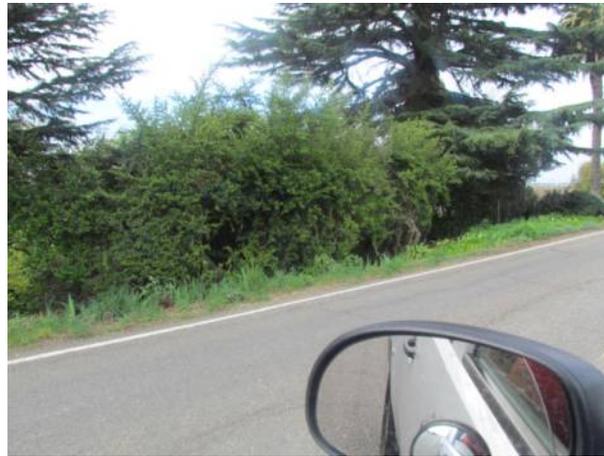
Levee Mile Report Line	75
Start Levee Mile	14.36
End Levee Mile	14.38
Location	Land Side
Category	Earthen Levee
Item	Vegetation
Looking west at landscaping on landside slope.	
richard_f_20121012_401.jpg

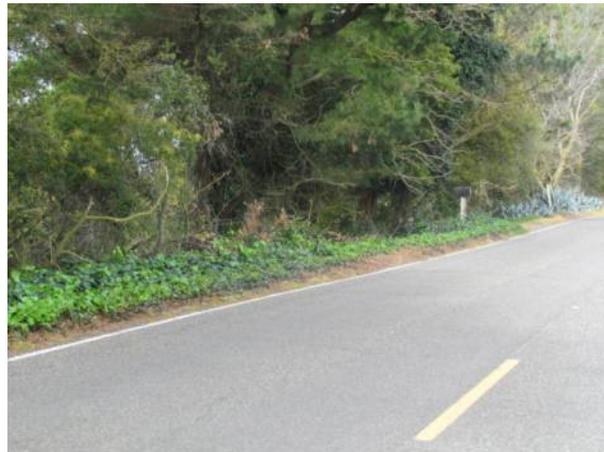
Levee Mile Report Line	76
Start Levee Mile	14.93
End Levee Mile	15.09
Location	Land Side
Category	Earthen Levee
Item	Vegetation
Looking northwest a dense landscaping on landside shoulder and slope.	
richard_f_20121012_410.jpg

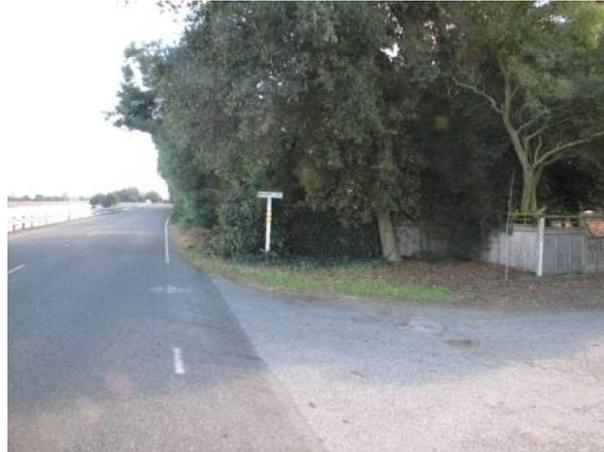
Levee Mile Report Line	78
Start Levee Mile	15.84
End Levee Mile	15.93
Location	Land Side
Category	Earthen Levee
Item	Vegetation
Looking south at landscaping on levee slope and toe obstruct access and visibility.	
richard_f_20121012_414.jpg

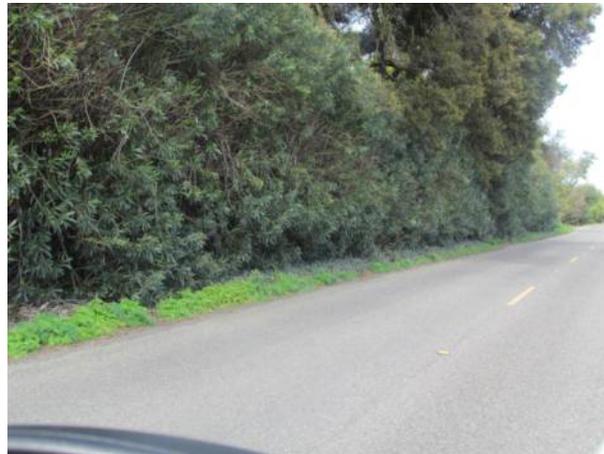
Levee Mile Report Line	78
Start Levee Mile	15.84
End Levee Mile	15.93
Location	Land Side
Category	Earthen Levee
Item	Vegetation
Looking northwest at dense landscaping on landside shoulder and slope.	
richard_f_20121012_415.jpg

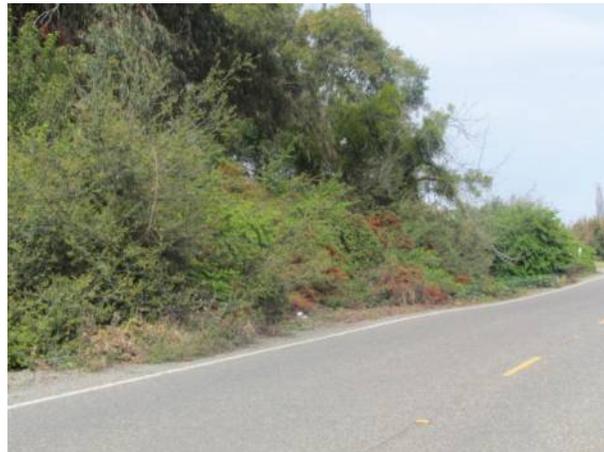
Levee Mile Report Line	79
Start Levee Mile	16.45
End Levee Mile	16.51
Location	Land Side
Category	Earthen Levee
Item	Vegetation
Looking west at dense landscaping on landside shoulder and slope.	
richard_f_20121012_405.jpg
